New Hampshire Volunteer Lake Assessment Program

2002 Bi-Annual Report for Mountainview Lake Sunapee

NHDES Water Division Watershed Management Bureau 6 Hazen Drive Concord, NH 03301

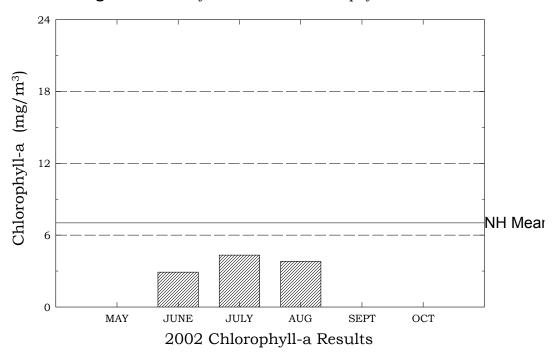
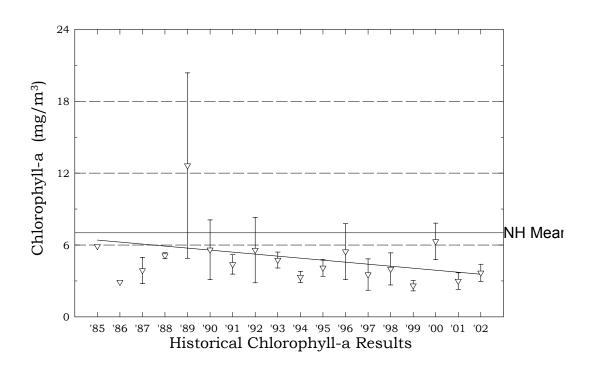
Figure 1. Monthly and Historical Chlorophyll-a Results

Figure 1 and Table 1: The graphs in Figure 1 (Appendix A) show the historical and current year chlorophyll-a concentration in the water column. Table 1 (Appendix B) lists the maximum, minimum, and mean concentration for each sampling season that the lake/pond has been monitored through the program.

The current year data (the top graph) show that the chlorophyll-a concentration *increased* from June to July, and then *decreased slightly* from July to August.

The historical data (the bottom graph) show that the 2002 chlorophyll-a mean is *less than* the state mean.

Overall, the statistical analysis of the historical data (the bottom graph) shows that the mean annual chlorophyll-a concentration has **not significantly changed** (either *increased* or *decreased*) since monitoring began in **1985**. Specifically, the chlorophyll-a concentration has remained **relatively stable**, ranging between approximately **3** and **6 ug/L**. (Note: Please refer to Appendix E for the detailed statistical analysis explanation and data print out.)

While algae are naturally present in all lakes/ponds, an excessive or increasing amount of any type is not welcomed. In freshwater lakes/ponds, phosphorus is the nutrient that algae depend upon for growth. Therefore, algal concentrations may increase when there is an increase in nonpoint sources of nutrient loading from the watershed, or in-lake sources of phosphorus loading (such as phosphorus releases from the sediments). It is important to continually educate residents about how activities within the watershed can affect phosphorus loading and lake quality.

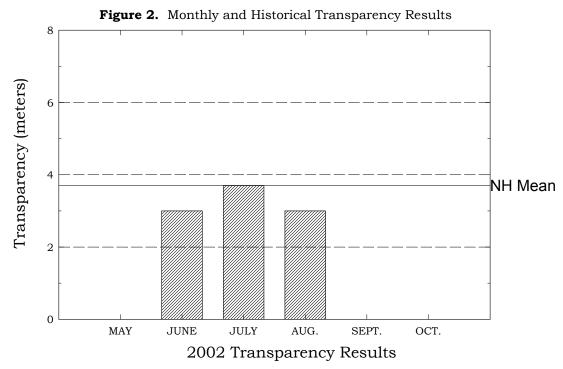
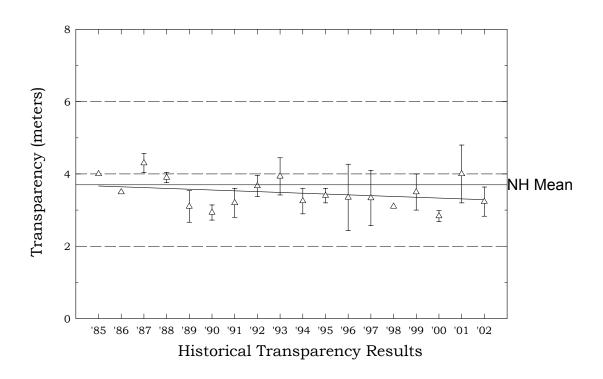
Figure 2 and Table 3: The graphs in Figure 2 (Appendix A) show historical and current year data for lake/pond transparency. Table 3 lists the maximum, minimum and mean transparency data for each sampling season that the lake/pond has been monitored through the program.

The current year data (the top graph) show that the in-lake transparency *increased* from June to July, and then *decreased* from July to August. The transparency in July was *approximately equal to* the state mean.

The historical data (the bottom graph) show that the 2002 mean transparency is *slightly less than* the state mean.

Overall, the statistical analysis of the historical data (the bottom graph) show that the mean annual in-lake transparency has **not significantly changed** (either *increased* or *decreased*) since monitoring began in **1985**. Specifically, the in-lake transparency has remained **relatively stable**, ranging between approximately **3** and **4** meters. (Note: Please refer to Appendix E for the statistical analysis explanation and data print out.)

Typically, high intensity rainfall causes erosion of sediments into lakes/ponds and streams, thus decreasing clarity. Efforts should continually be made to stabilize stream banks, lake/pond shorelines, disturbed soils within the watershed, and especially dirt roads located immediately adjacent to the edge of tributaries and the lake/pond. Guides to Best Management Practices designed to reduce, and possibly even eliminate, nonpoint source pollutants, such as sediment loading, are available from NHDES upon request.
